Transportation Safety Board
of Canada

MARINE INVESTIGATION REPORT
M13N0014

CAPSIZING OF TOW AND ACCIDENTAL DEATH
TUG WESTERN TUGGER AND BARGE ARCTIC LIFT I
33 NAUTICAL MILES SOUTHWEST OF BURGIO,
NEWFOUNDLAND AND LABRADOR
10 MAY 2013

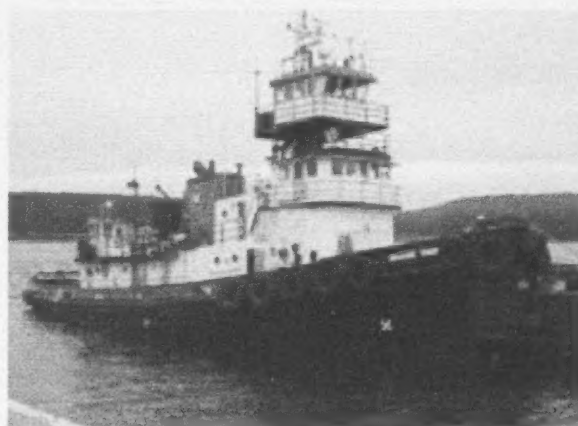
Photo 2. The *Western Tugger*

The *Western Tugger* is a coastal tug of steel construction that was built in 1943 and purchased by the current owner in 2007 (Photo 2). The vessel has a single propeller and rudder. The conning station, located in the wheelhouse that sits atop the deckhouse, is fitted with navigational equipment including radars, a very high frequency (VHF) radiotelephone, a global positioning system (GPS), an automatic identification system, an electronic chart plotter, and an autopilot. The deckhouse includes a galley, storerooms, and accommodations.
